German Railway Gun

Leopold

28 cm K5 (E)

Jan Coen Wijnstok

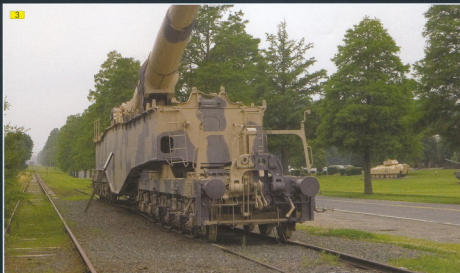
3.4 The hinges of the firing bed coupling are riveted to the top and bottom of the railway trucks bed (see photo [175]).

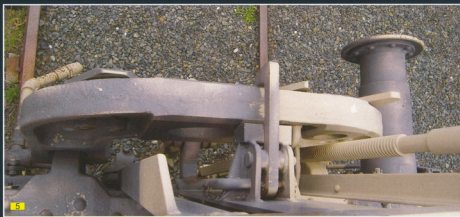
3.5 The top of the coupling; note the hook used to secure it. Next to it is the threaded part of the handbrake operating rod.

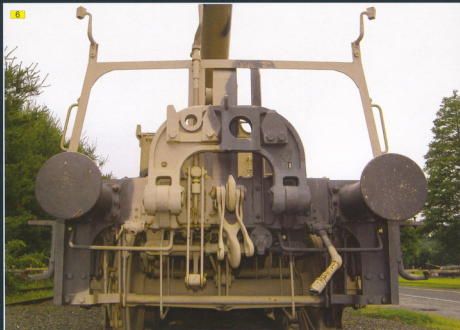
3.6 Overall view of the front of the railway truck. The firing bed coupling is in the middle. The vehicle coupling and the operating mechanism for the handbrake are situated within its arch. To the left and right of its hinges are angle cocks for pressure hoses. There were two separate systems, one for compressed air running through the left side of the vehicle and one for steam on the other side. The compressed air system was in use on 'Leopold' as can be seen by the surviving hoses. The steam system would have been used in conjunction with a steam locomotive.

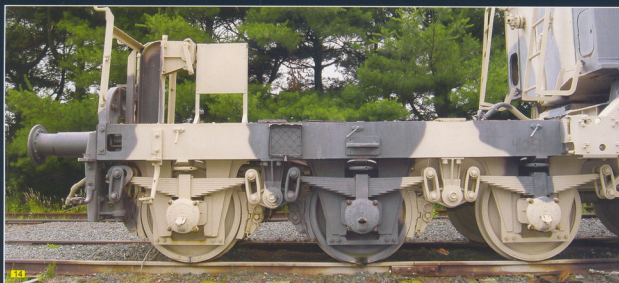
14 Side view of the railway truck. The plaque next to the winch is not original, but a museum addition.

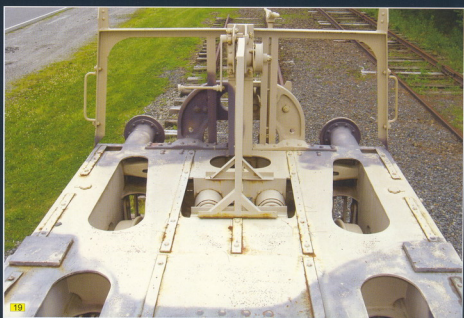
19 Another view of the deck of the railway truck. The strips running lengthwise were used to attach the wooden slats of the work surface.

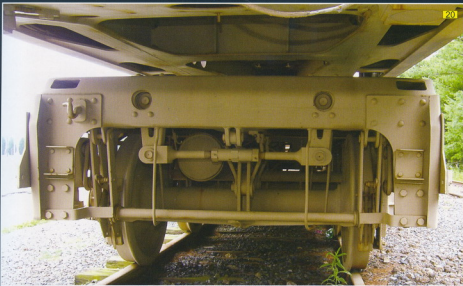
20 View of the railway truck from underneath the gondola. Its bottom can just be seen in the top of the picture. To the left and right are the hangers for the brake shoes. They are joined at the bottom to a rod that connects to the central brake mechanism seen in the middle. On the top left is a hook for attachment of the chain connecting the railway truck and the gondola in transport. This chain would have prevented the railway truck from shearing when derailling. Keeping the trucks in a straight line would minimize damage in case of accidents. Bear in mind that K5's were able to use bad or quickly laid temporary track, so accidents were taken into account.

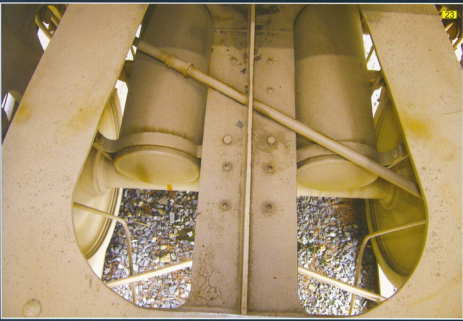
21 22 23 Several views of the pressure vessels for the brakes. The pressure drives central brake cylinders that operate the brakes through a system of rods and hangers.

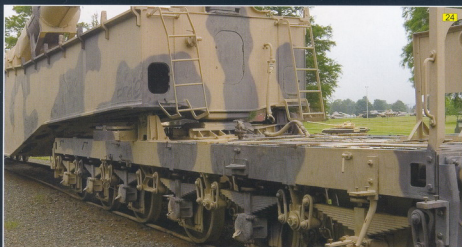
24 View of the rear of the railway truck with the pivot and traversing mechanism. The main aiming of the gun was done by means of either a curve in the rails or the turntable. For fine adjustment, the gondola could be traversed about two degrees to either side.

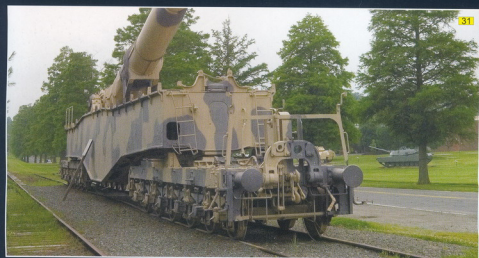
331 View of the front railway truck and the gondola.

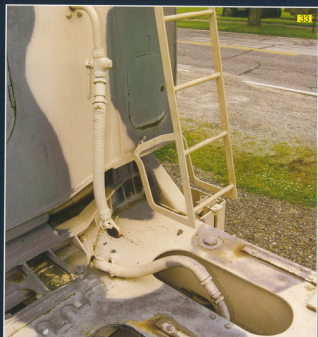
137 Overall view of the gondola. A round bolted cover and levers can be seen on the front left side. The round cover closes off the access hatch for installing an auxiliary motor in case the generator does not function. The levers are for hand operation of the elevation brakes, which are normally operated electrically. This is an automated system to prevent the barrel from dropping when the equilibrator fails.

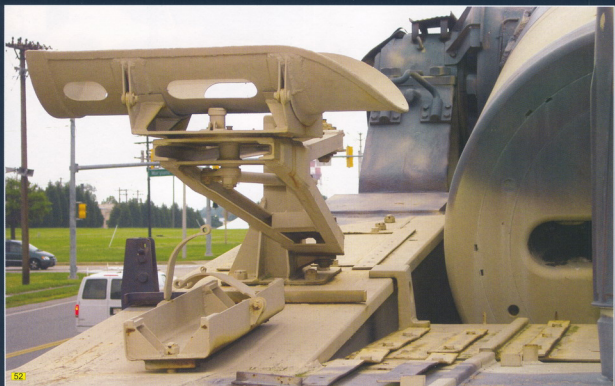
653 A good view of the cartridge catcher. The stand for the rammer should be behind it. This rammer was used to release the breechblock when it became jammed. The container in front is for stowing it (see photo [171]).

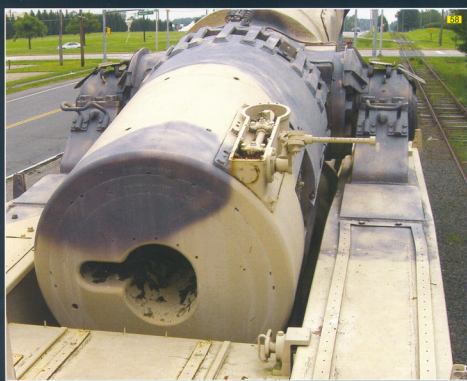
56 57 Looking to the rear at the breech, where it comes up against the gun cradle. The welded strips are not original and probably keep the barrel from sliding back.

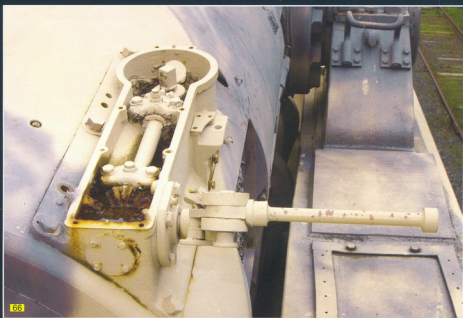
62 63 64 65 66 67 Six different views of the breechblock operating mechanism. It moves the breechblock sideways to open and close the breech. The gears can be clearly seen inside. The cover is missing, as is that on the round hole facing front (see photo [67]). The crank once had a wooden handle.

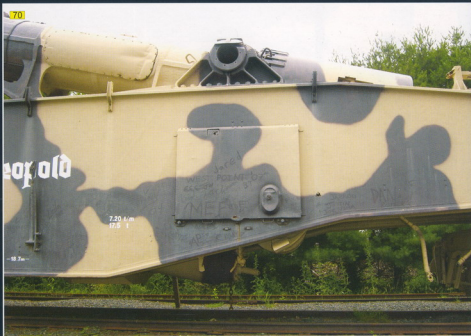
763 A good view of the middle section of the gondola, with the indicator for recoil slide in the middle and the manhole cover to the left. The gun-cradle is seen above, including a good view of the side cover.

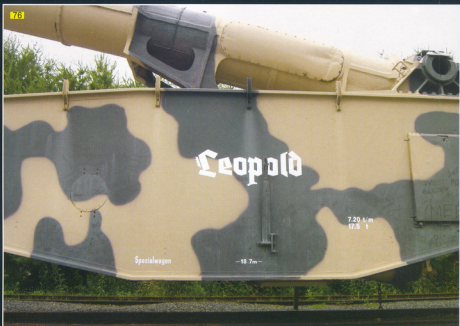
774 The gun-cradle is a one piece casting. Its front end is seen here.

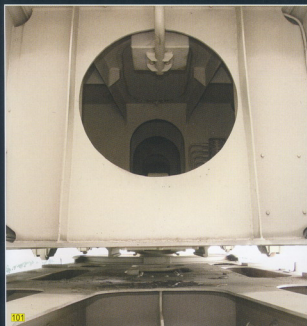
101 Access hatch into the rear compartment of the gondola from underneath the gun. The object seen in the top of the hatch is the counterweight for the loading flap, which is right above.

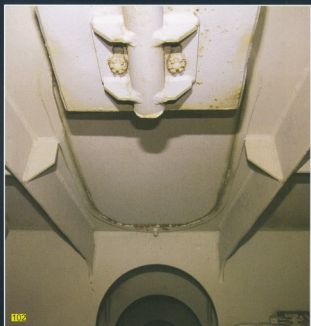
102 Another look at the counterweight; a hatch can be seen above it. Note all the stiffeners on the roof members.

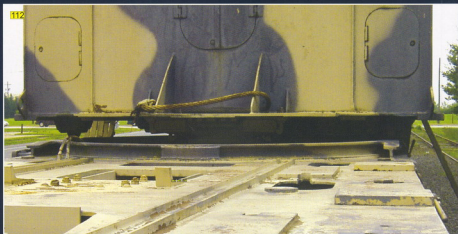
116 The lightening holes in the deck of the railway truck also provide access from the top. There were no wooden work surfaces on the rear railway truck. Note the rails for the generator unit running between the holes.

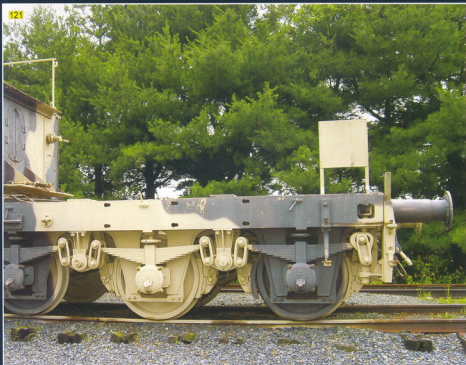
121 The construction that keeps the leaf springs in line. A rod running across the width of the truck connects the outer ones on both ends of the railway truck.

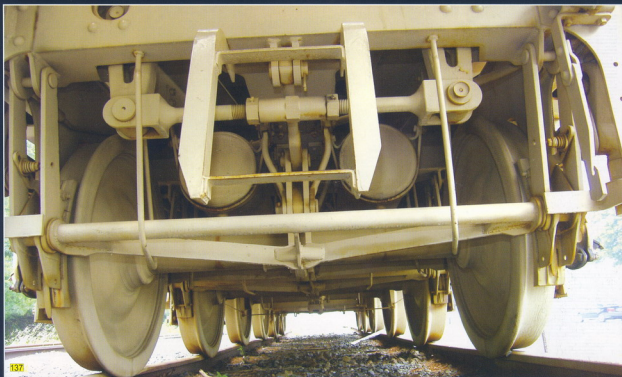
[142] The right rear views of the rear railway truck and gondola. These pictures make clear that both sides of the gun are essentially the same. The gun is operated from the other side, so this side is simpler in layout. Note that the name "Leopold" should also be on this side of the gondola. The ladder on this side is missing.

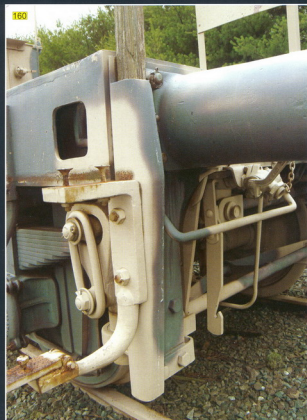
163 164 165 Head-on views of the front of the railway truck. The angle cocks for the air and steam hoses are next to the buffers, only the air hose is in use. Above them are the brackets and retaining pins used to secure the rails for pulling the generator unit onto the rear railway truck. The generator was transported on the Munitionszubringewagen (ammunition supply car).

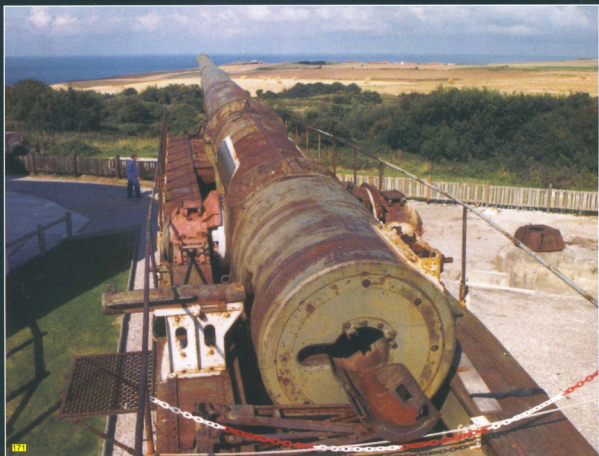
174 In 1980, a 31 m long railway gun was discovered behind a factory building of the state artillery workshop in Tarbes, in the south of France. It turned out to be a 28 cm K5 (E). There was interest from quite a few museums, but in the end it went to the Musée du Mur de l'Atlantique (Atlantic Wall Museum) on the Channel coast. Back in a place where K5's were frequently used to shell Great Britain from prepared positions, complete with bunkers for protection and hiding. How or why the gun wound up in Tarbes is unknown. Not even where it came from is clear, best guess is that it is one of the guns from Eisenbahnbatterie 749 that were overrun by the Allies near Montelimar, in the Rhone-valley. The guns stationed on the Channel coast retreated to The Netherlands in September

1944 and were destroyed there. The gun was manufactured by Krupp in 1941, when a total of seven guns was delivered. It is an Ausführung D (Model D), which has the aiming stand in a high position. There was no transport cover for the aiming stand, as on 'Leopold'. The gun was repainted green and all the lettering has gone so no carriage number is known.

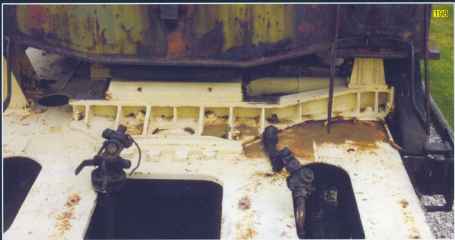
1433 1434 2006 The front of the traversing mechanism. Note the sliding cover for the operating shaft.

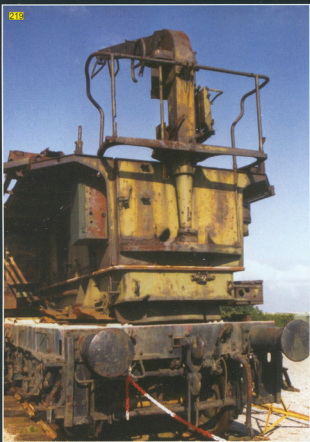
P221 A view of the side of the generator unit. The operators were on the opposite side. The exhausts are missing on both sides, as is the generator itself.

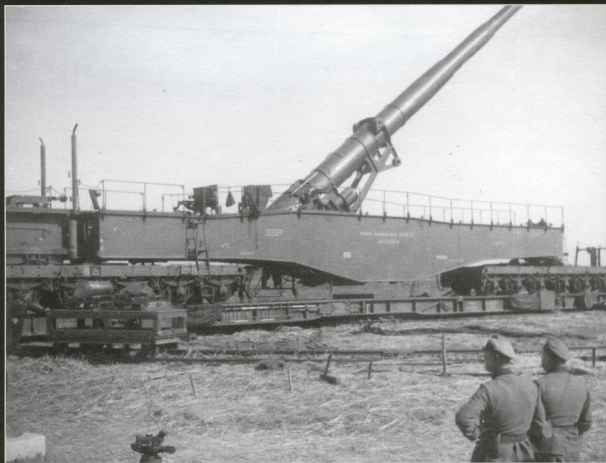
[Left] Here we see carriage number 919214. There is no provision for the Sprengwerk. When or where this photograph was taken is unknown. Since it has uniform dark gray camouflage it must be after 1939. On top of the loading platform is one of the rammers for loading the gun. The light diagonal line going from the breech of the gun to the left is the lanyard for firing the gun. [Marcel Verhaaf Collection]

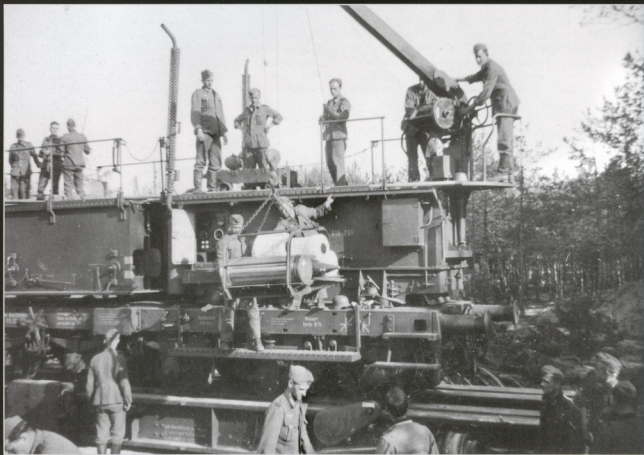
[Below] This is a very good view of the generator and crane in action. The railings on the generator unit are small; the large gap was necessary to accommodate the ammunition trolley. Note that it can be closed with chains. The instrument panel of the generator can be seen clearly. The inside of the door is padded and probably white or off-white. The carriage number on the generator is 919201. The wheels of the ammunition trolley have round holes. [Marcel Verhaaf Collection]

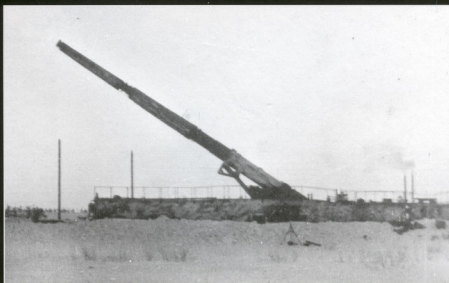
[Right] This K5 seems to be in patchy winter camouflage. The function of the fixtures on the barrel is unknown. This photograph may have been taken in the Soviet Union. [Marcel Verhaaf Collection]

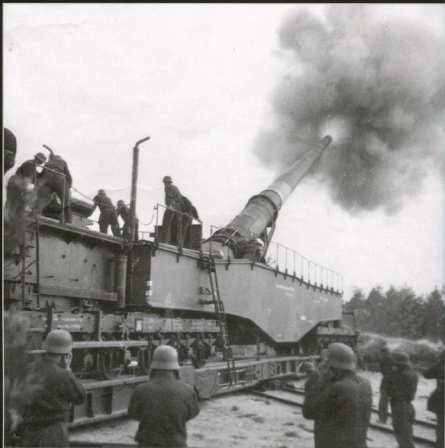
[Right] K5 fires a round, the men on the gun are bracing themselves for the recoil. All personnel seem to be wearing overalls. The pivot of the firing bed can be seen resting on the existing rail on which the turntable is built. No carriage number can be read. [Marcel Verhaaf Collection]

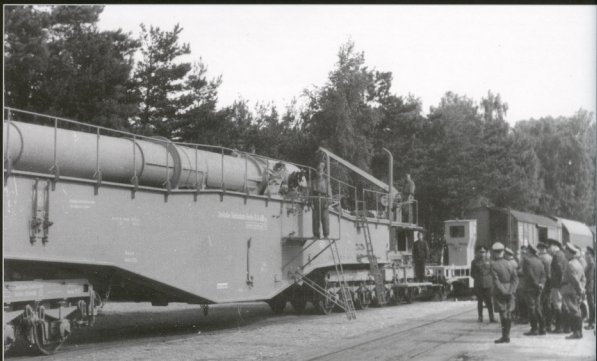
[Right] A K5 in France, seen in one of the bunkers that were built to hide and protect them. It is in firing mode, since the generator is on the gun. The bunkers were made to look like barns. Note the big sliding doors; with all the rivets, they seem to be steel. Judging from the uniforms, this must be later in the war. [Marcel Verhaaf Collection]

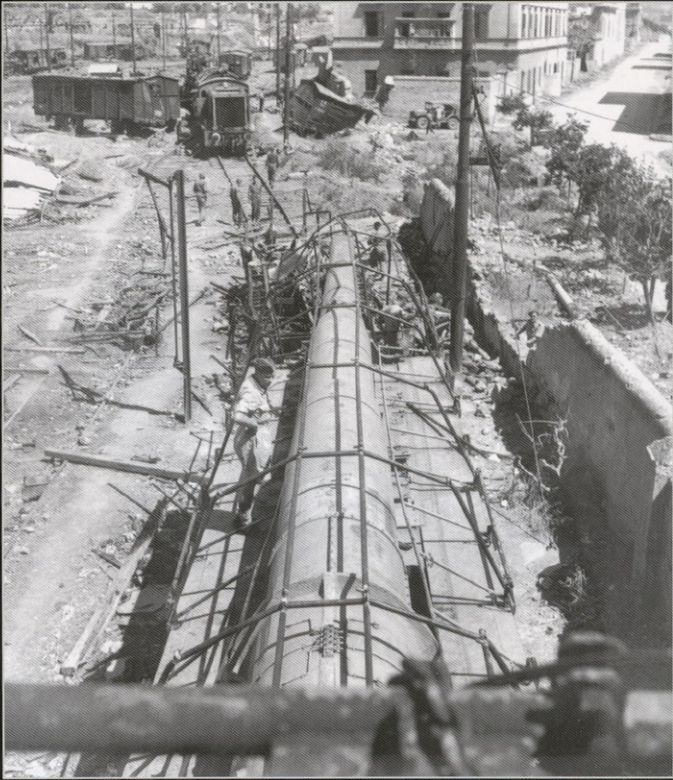
[Below left] This is 'Robert', carriage number 919215, after its capture. The rammer stand to the side of the breech is missing, just like on 'Leopold'. This is probably consistent with the method used for rendering the guns incapable of firing. Here as well, the frame is still in place. Other photographs show it will disappear over time. Note that the frame attaches to the same brackets as the uprights of the railing. The paint job is very uneven and squiggly. [Photograph NA 16346 courtesy of the Imperial War Museum, London]

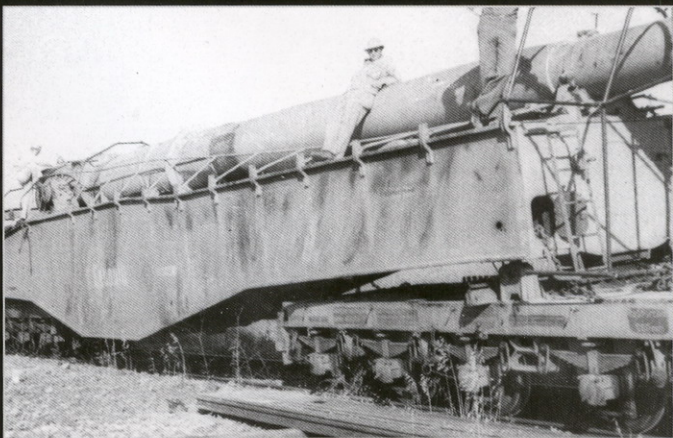
[Right] This photograph shows 'Leopold'. The frames for camouflage with tarpaulins are still in place on the front of the gondola and near the breech. Note the way the railings fold down. The paint seems very uneven and mottled. On the gondola, the white lettering can hardly be distinguished, and dark gray patches have been left around the lettering on the railway truck. The extra structure on the traversing mechanism can be seen behind the support wheel. [Marcel Verhaaf Collection]

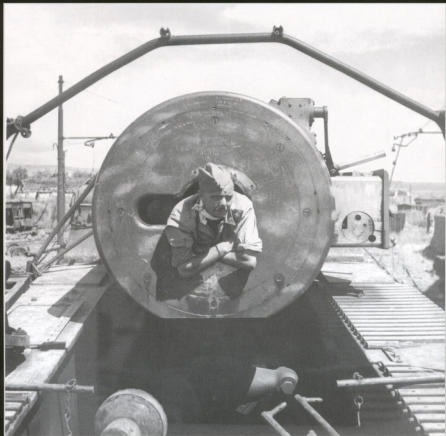
[Above] This photograph gives a very good impression of the size of K5's breech. Note the detail on the breech-block. The head of one of the loading ramrods can be seen in the bottom of the photograph. Since the stand for the rammer next to the breech is missing on both guns, it is impossible to say which K5 this is. [Photograph NA 16347 courtesy of the Imperial War Museum, London]

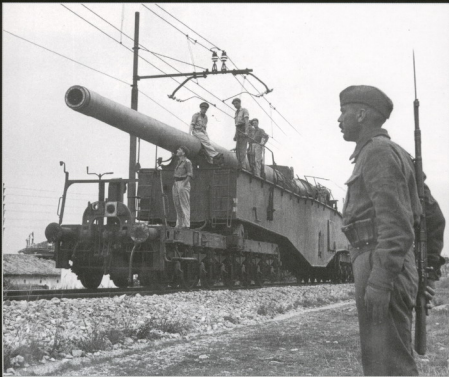
[Right] This K5 has some damage, but it seems largely intact. On most K5s there is a circular hatch on the left front of the gondola, next to the set of handles. An auxiliary motor to operate the gun in case of power loss could be attached here. This vehicle has no such hatch. Only the very first two guns produced didn't have this provision. The guard in the foreground is intriguing as well. He seems to be wearing British battle dress, but with German ammunition pouches and rifle. Maybe this is a member of the resistance. The men on the gun are British Commonwealth troops. [Photograph NA 25193 courtesy of the Imperial War Museum, London]

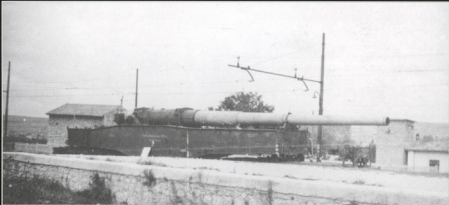
[Right] In this and the following photographs, a distinct difference in color can be seen between the carriage itself and the barrel. Note that the cradle has the same color as the carriage. Here is visible proof of the barrel being replaced when it was worn out or the particular ammunition it fired ran out. This barrel change must have taken place after the 1943 replacement of dark gray with dark yellow. No effort was spent on repainting the carriage itself. [Jeffrey Plowman Collection via Daniele Guglielmi]

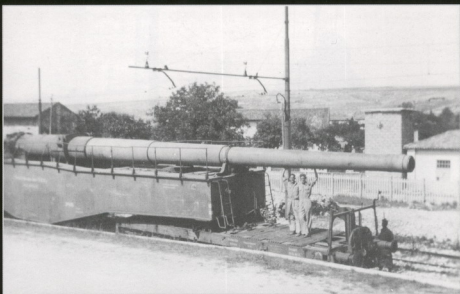
[Right and bottom] These photos were taken in a railway station. The difference in color between the carriage and the barrel is obvious here. [Jeffrey Plowman Collection via Daniele Guglielmi]

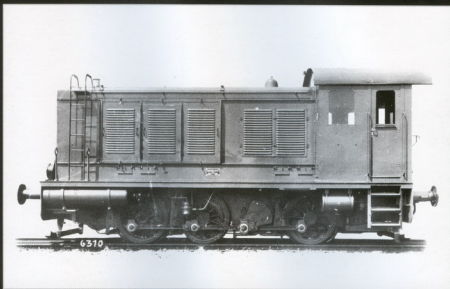
[Left] A WR360C14 diesel locomotive seen from the side. This was the most numerous German diesel locomotive. They were used for shunting purposes on all fronts, both by the Wehrmacht and the Reichsbahn. For work in fuel and ammunition dumps, diesel locomotives were preferred to steam locomotives that produced sparks, as they were safer. They were also used to shunt K5's to their firing positions since they do not produce huge clouds of smoke and steam. They would thus be less conspicuous from the air. [Marcel Verhaaf Collection]

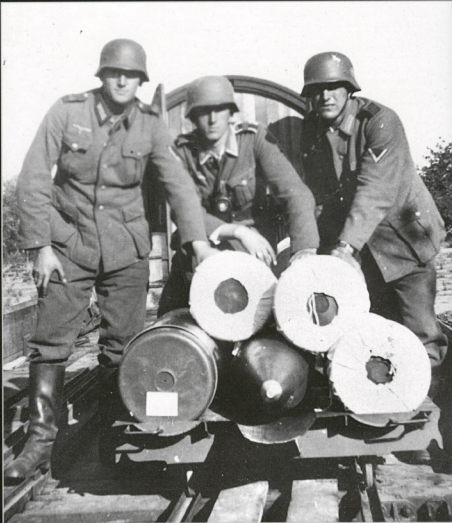
[Right] The ammunition crew showing their stuff. The ammunition trolley carries the maximum charge, consisting of two large and one small bags of propellant, plus the main charge in the cartridge case. Altogether they weighed about 250 kg (552 lb). The projectile adds another 255.5 kg (564 lb) to the load. The men are on the ammunition supply car. Note that there are three rails; the generator unit ran on the outer ones. [Marcel Verhaaf Collection]

tubes with stiff top and bottom. The main charge of 60 kg (132 lb), in its cloth bag, was loaded into the cartridge and then capped to secure it. This is the Hauptkartusche. Stenciled lettering appeared only on the cloth bags, including that of the main charge. The lettering runs across the charge in the drawings, but in period photographs I have seen, it runs lengthwise. Both practices may have been in use. The cartridge case may have had stenciled codes on the base, but none can be seen in period photographs. They would have been reused, only the percussion primer had to be replaced. Maybe only this item carried codes. Codes for checking were on the cloth bag of the main charge.
